## 3. New approaches to water main cleansing

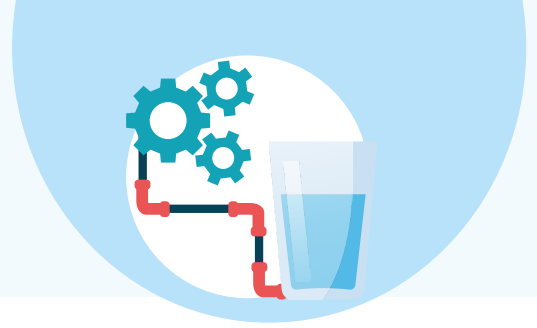
As can be seen in the adjacent picture, deposits naturally build up in our large network of pipes (which is laid out end-to-end would go almost three quarters of the way around the earth). Although harmless, they still require regular cleansing if we are to avoid issues with colour and taste. Traditional methods of cleansing can be disruptive to customers and in themselves may cause water quality issues. Replacement of structurally sound pipe before its end of life due to water quality issues does not represent value for money.
